Ring Type Joint Machining

Moss were approached by a Aberdeen fabrication company with regard to the machining of a subsea tie in spool that had been sent onshore for refurbishment.

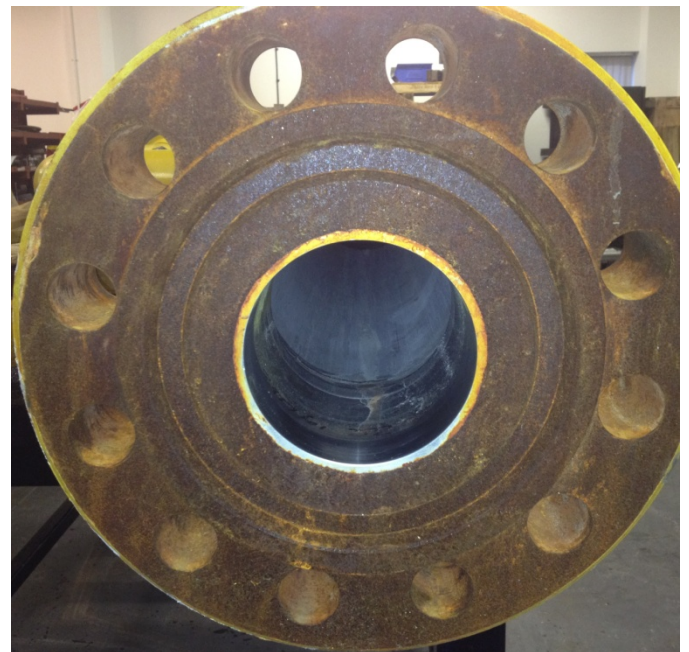
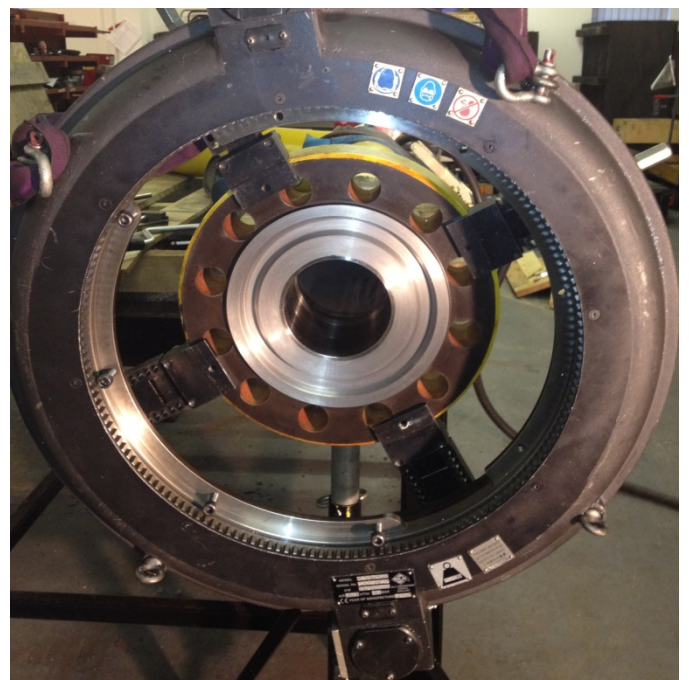
The spool had been stored open to the elements and when it was required for installation it was not fit for purpose due to the heavy corrosion on the flange sealing faces. Both 7.1/6" 5K BX156 seal grooves required machining to remove the corrosion and pitting and return the dimensional sizes back to tolerance.

Competent Moss technicians and an external mount flange facing machine was used to machine the faces and angles of the sealing groove. The corrosion was removed and the dimensions were measured using ball trammels to ensure the necessary tolerances of +/- 0.05mm (0.002") were achieved.

Dimensional reports were produced for each flange, detailing both pre and post machining sizes satisfying the project quality plan. The spool was returned to the fabricator where it was successfully hydrotested ready for installation load out within the required timeframe.
